Still Majestic

PROSOCO and the LaSalle Bank Theatre & Hampton Majestic Hotel

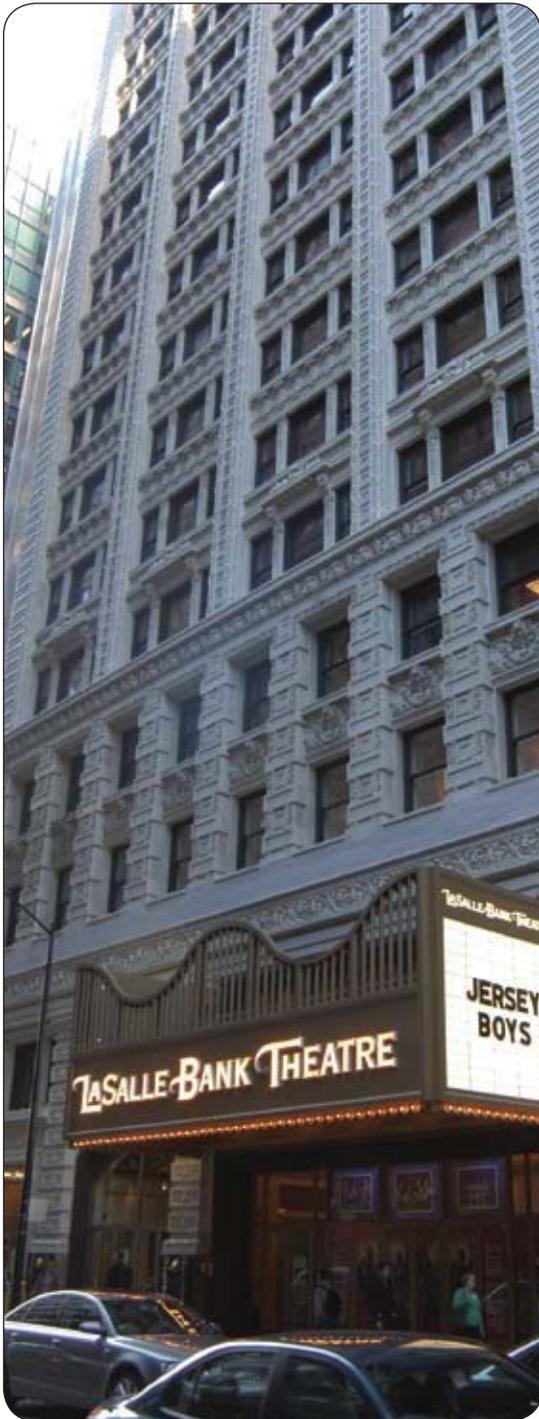
A rose by any other name -- LaSalle Bank Theatre & Hampton Majestic Hotel's 20-story show of creamy white terra cotta was cleaned with PROSOCO products in 2006 as part of a \$40 million restoration.

There's a show on the outside, too. The building's cladding is a lavish 20-story exhibition of creamy white terra cotta ornamentation. The decoration-encrusted exterior is rich with wreaths and flowers, lion heads, shells, shields, scrolls and more.

The exterior masonry needed an enormous amount of work too. Long-term repairs had been deferred for more than a decade. In the late 90s, a large section of the terra cotta cornice fell, leaving the entirety of the ornamental exterior suspect, said Richard Koenigsberg, professional engineer and president of Koenigsberg Engineering, P.C., Chicago and New York.

The PWS crew used Sure Klean® 766 Limestone & Masonry Prewash, followed by Sure Klean® Limestone & Masonry Afterwash to rid the original terra cotta of its dark and dingy mantle.

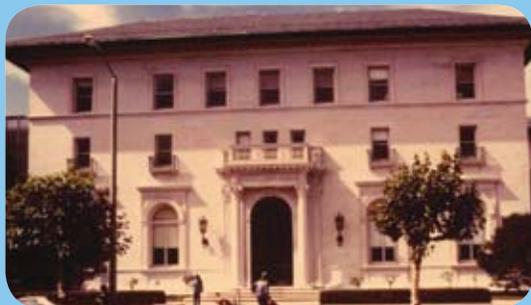
Can You Identify This Project?

This Italian Renaissance mansion was built 92 years ago on a hill so steep that horse-drawn vehicles couldn't climb it safely. It's Tennessee pink marble with a granite base. In the summer of its 71st year, the building got a cleaning with PROSOCO's Sure Klean® 766 Limestone & Masonry Prewash to remove heavy dirt and carbon soiling from under eaves, windows, and carved areas. With those areas clean, the place got a full cleaning with a very dilute solution of Sure Klean® Limestone Restorer.

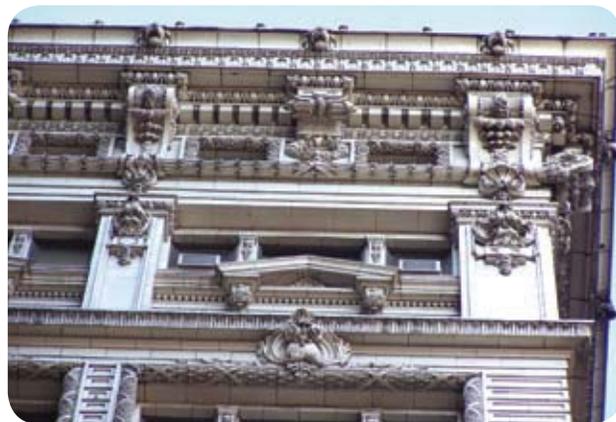
No room for error -- installing custom-made replacement pieces of cornice weighing up to 600 pounds, from swing stages 20 stories up was a delicate and precise operation.

Reconstruction of the failing cornice took custom fabrication of many of the largest pieces, some weighing up to 600 pounds and taking four months to make. Installation had to be delicate and precise.

"There is no room for error when you are installing immense pieces of terra cotta more than 20 stories in the air from swing stages that cantilever more than 10 feet over a crowded Chicago street," commented Steve Maggio, project manager for Bulley & Andrews.

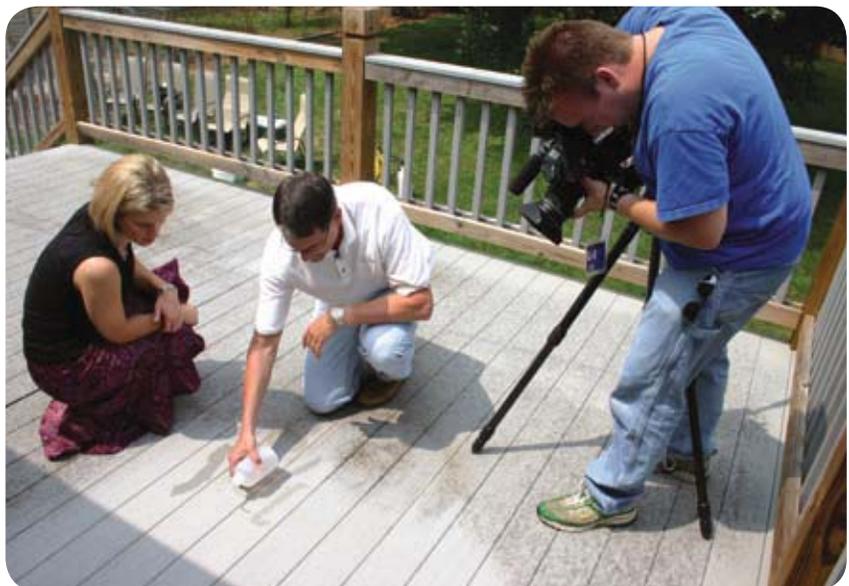
PROSOCO’s Director of Marketing Scott Buscher demonstrates the water-repellent qualities of Enviro Klean® Composite Deck Protector for KSHB “Call for action” reporter Jenn Strathman and cameraman Mike Connor.

The segment showed water soaking into the unprotected section of the test panel, cleaned with Enviro Klean® Composite Deck Restorer. Then, viewers saw the water bead up on the section treated with Enviro Klean® Composite Deck Protector.

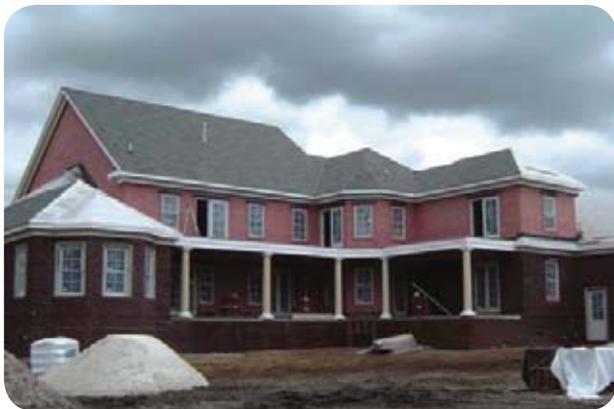
Glowing clouds over this R-GUARD™-protected luxury home going up in Myrtle Beach speak to the importance of the air barrier’s water-resistive qualities. Coated with red R-GUARD™, the upper stories can still dry in, despite rain, even though the brick cladding isn’t yet installed.

Applied to the structural walls, the red, water-based, fluid-applied coating’s driving purpose is reduction of the building’s heating and cooling costs, says Bob Gallagher, PROCON. The VOC-compliant air barrier stops air leakage in and out of the building – air leakage that can waste up to 40 percent of the building’s heating and cooling costs, according to the U.S. Department of Energy.

The PROCON crew brushed, rolled and troweled PROSOCO R-GUARD™ onto about 12,000 square feet of structural wall, Mr. Gallagher said. The air barrier can also be spray-applied.

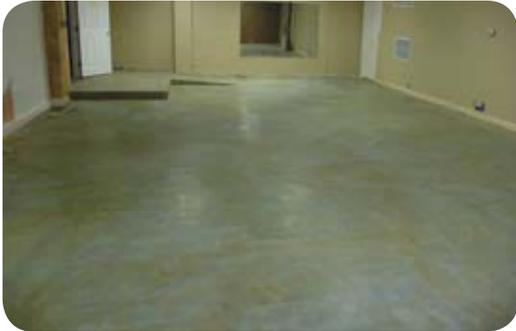
No Consolideck® LS Guard

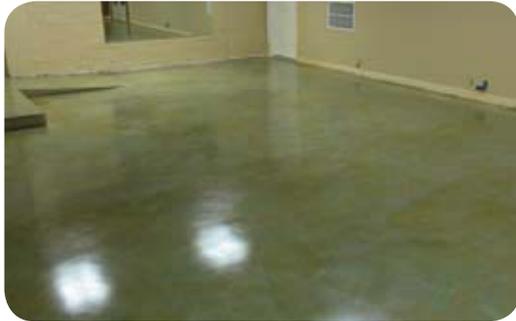
One coat of Consolideck® LS Guard

He turned to Consolideck® LS Guard. The lithium silicate treatment penetrates the concrete "wear zone" – the top 1/8 to 1/4 of an inch. There, it reacts with the substrate to fill the concrete pores with insoluble calcium silicate hydrate. It's the same tough stuff you get in concrete when Portland cement cures – just more of it, making the concrete even harder and denser.

Mr. Holmes brushed two coats of the milky white liquid onto the deck with lamb's wool applicators. On his first pass, he got about 300 square feet per gallon. That coverage rate jumped to 700-800 square feet on the second application.

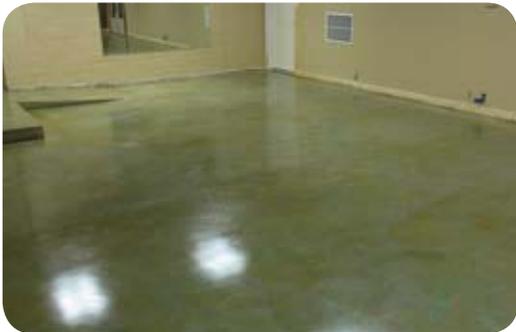
Two coats of Consolideck® LS Guard

LS Guard produces a protective film that gives the hardened concrete a semi-gloss shine and protection from spills and stains.
